Manhole Inspection Summary

Manhole # S13C1_021MH

Location Address: **S Caton Ave**

Cross Street: **Clarinda Ave**

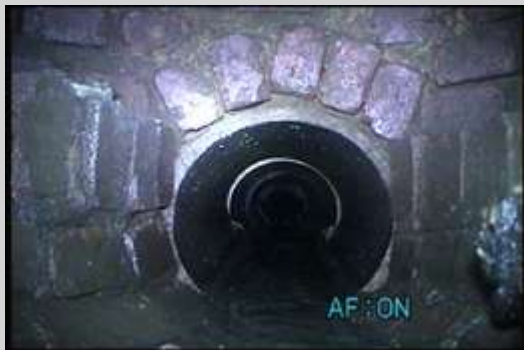
12 O'Clock Outflow

10 in. Circular Gravity Sewer
Pipe Out @ 12 O'Clock

Pipe Height: **10.8** (in.) Rod and Bar (Angled)
Pipe Material: **Clay** ☐ Pipe Lined
Invert Depth: **10.96** (ft.) Flow Characteristics: **Fast**
Deposits: ☒ None ☐ Mud ☐ Sludge ☐ Debris ☐ Grease
Silt Depth: **0** (in.) Deposits Extent:
Infiltration: **None** Pipe Seal Cond: **Sound**

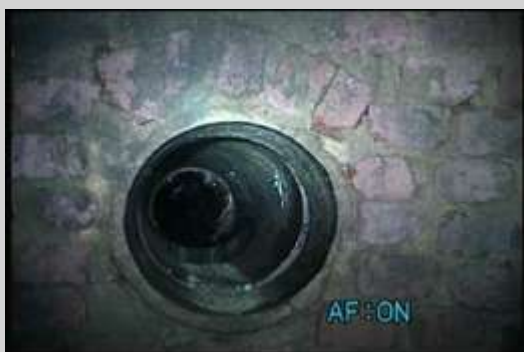
3 O'Clock Inflow

10 in. Circular Gravity Sewer
Pipe In @ 3 O'Clock

Pipe Height: **10.8** (in.) Rod and Bar (Angled)
Pipe Material: **Clay** ☐ Pipe Lined
Invert Depth: **8.25** (ft.) Flow Characteristics: **Slow**
Deposits: ☒ None ☐ Mud ☐ Sludge ☐ Debris ☐ Grease
Silt Depth: **0** (in.) Deposits Extent:
Infiltration: **None** Pipe Seal Cond: **Sound**

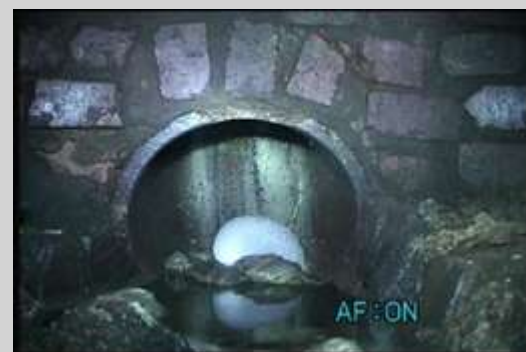
Drop In @ 3 O'Clock

Drop: **Outside** Rod and Bar
Angled: **Yes** Reading: **9.28** (ft.)
Inv Depth: **10.28** (ft.)
Drop Condition: **Open**

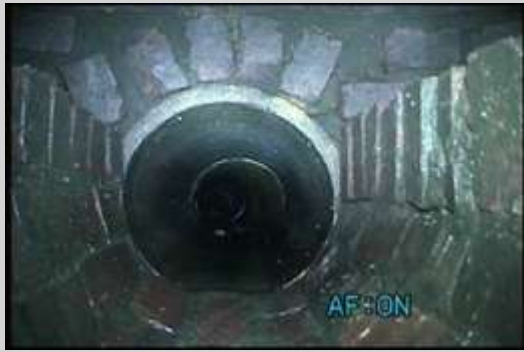
6 O'Clock Inflow

10 in. Circular Gravity Sewer

Pipe In @ 6 O'Clock

Pipe Height: **10.8** (in.) Rod and Bar (Angled)

Pipe Material: **Clay** ☐ Pipe Lined

Infiltration: **None** Pipe Seal Cond: **Sound**
